CAUSES, CONTROL,
And
PREVENTION OF GULLIES
At Various New England Locations

Conservation Research Report No. 2

Agricultural Research Service
UNITED STATES DEPARTMENT OF AGRICULTURE
In Cooperation With
New Hampshire Agricultural Experiment Station

BY ROBERT S. PALMER, *agricultural engineer, Soil and Water Conservation Research Division, Agricultural Research Service, and adjunct professor of agricultural engineering, University of New Hampshire*¹

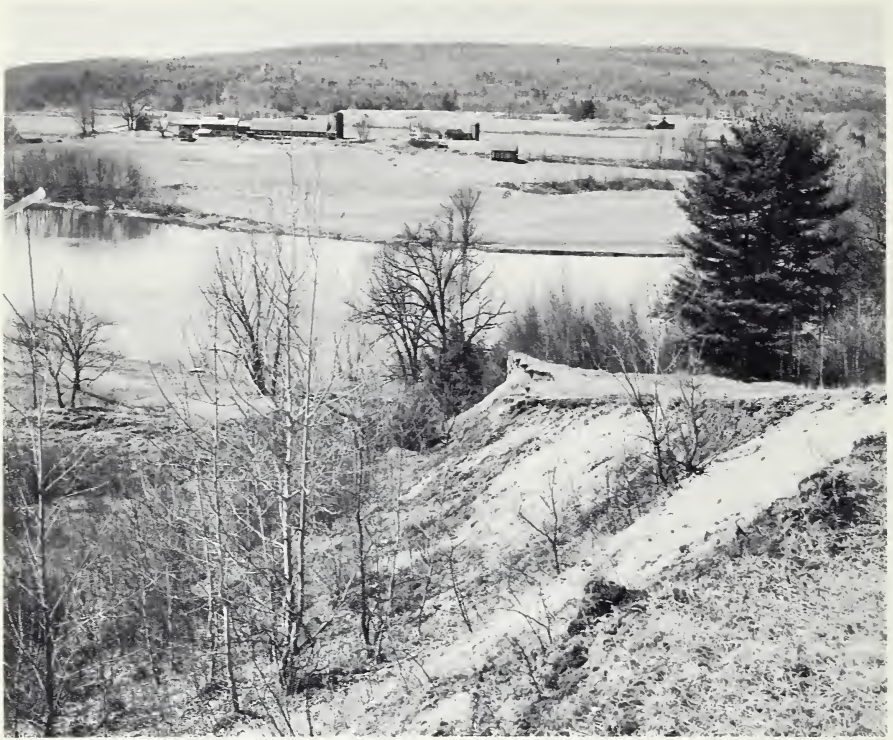
FIGURE 1.—View of Connecticut River from eroding first terrace. In background is a Vermont bottom-land farm. Westmoreland, N.H., 1959.

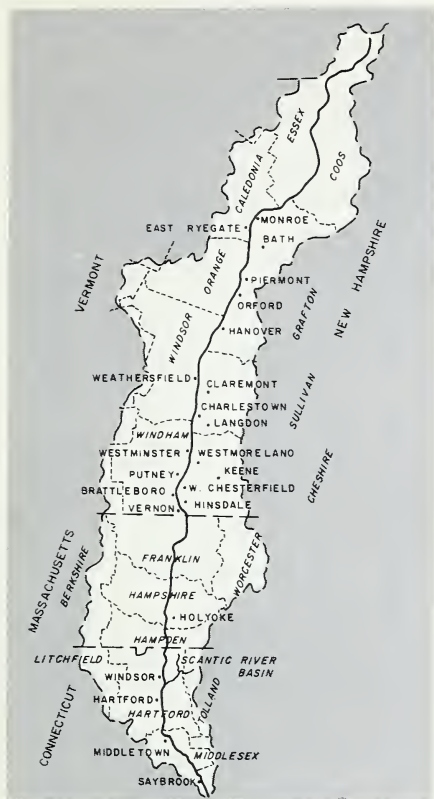
FIGURE 2.—Map of Connecticut River Basin.

The Connecticut River is the longest river in New England, and the Connecticut River Valley is often called the heartland of New England. It has affected the region's development because of its strategic location. Figure 2 is a map of the Connecticut River Basin,

showing many of the places mentioned in this report.

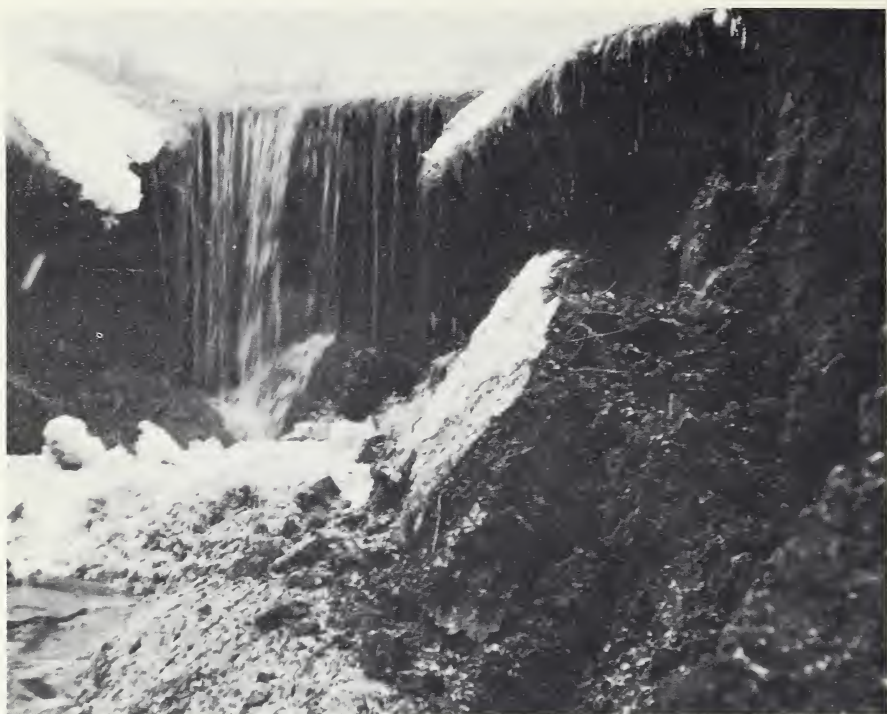
FIGURE 3.—Surface runoff initiating gully. Note undercutting and large sod blocks in bottom of gully. Claremont, N.H., 1960.

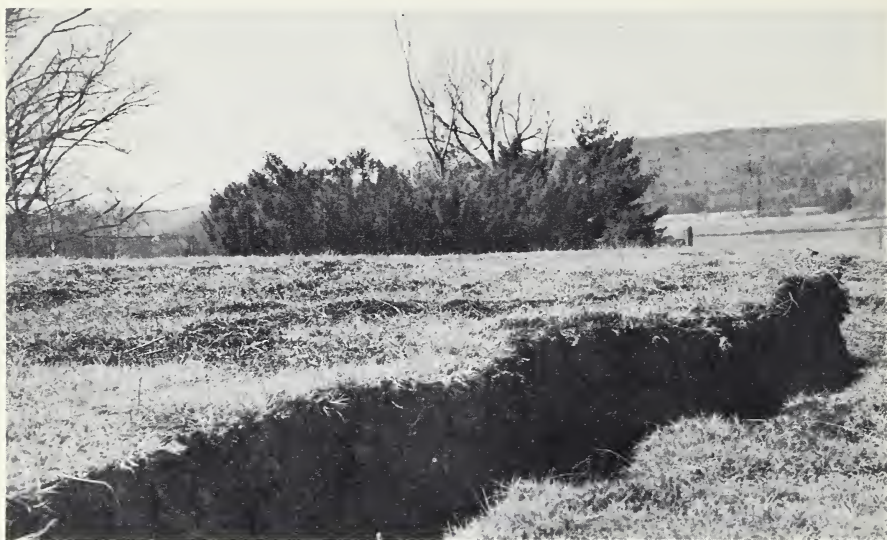
FIGURE 4.—About 20 inches of differential settlement above gully sidewall caused by freezing and spring thaw. Westmoreland, N.H., 1959.

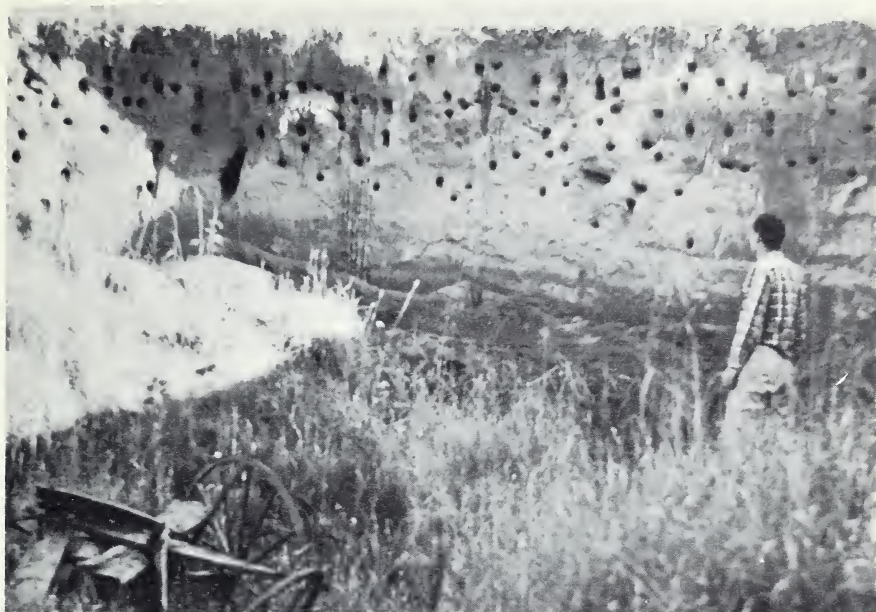
FIGURE 5.—Sand swallow nests extending 30 to 40 inches into sidewalls of gully. Claremont, N.H.

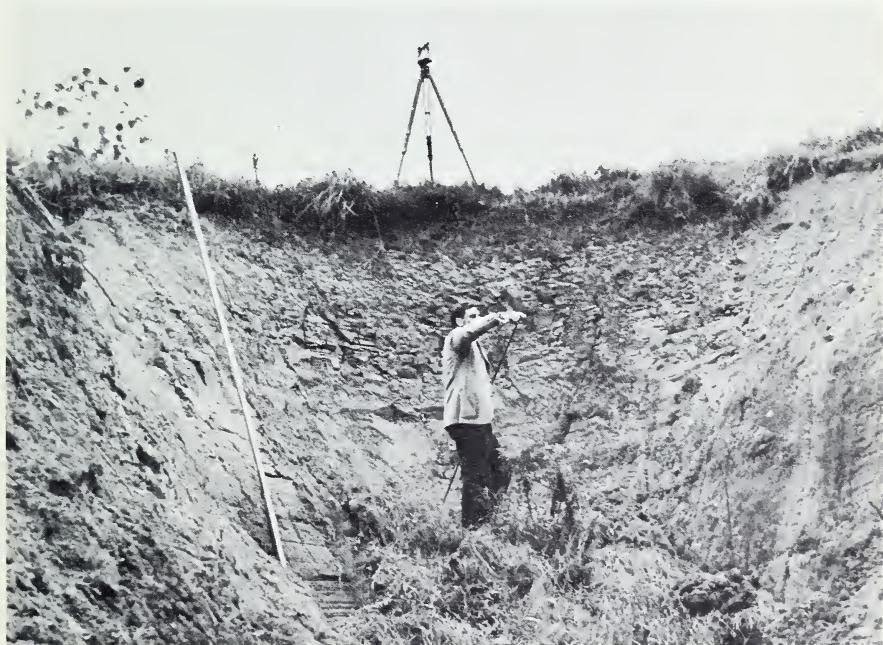
FIGURE 8.—Setting reinforcing rods in gully sidewalls to aid in making surveys and visual observations. Orford, N.H., 1957.

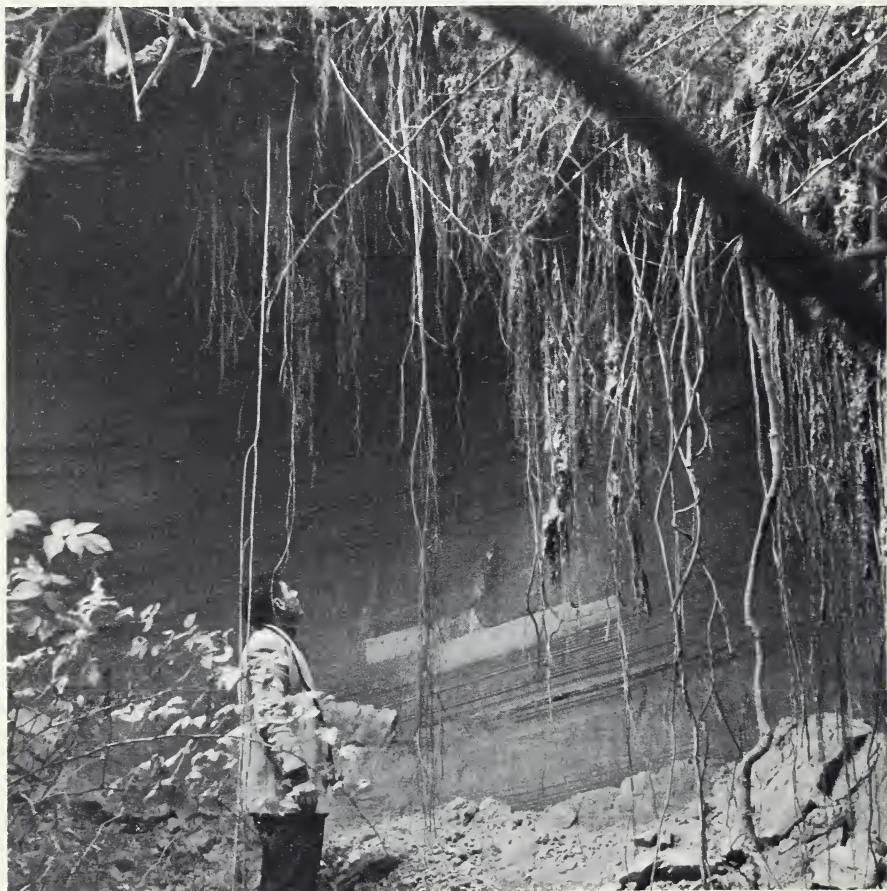
FIGURE 9.—Gully in varve clay. This soil on the second terrace is very prone to slide. Tree roots overhead have shallow rooting depths. Orford, N.H.

Several trees have toppled into the gully, and along the rim some large trees have caused tension cracks. The root systems hang out in space, as shown in figure 9. In time these upright trees will fall, tearing large pieces of sod and soil from the gully rim. Most of these root systems extend laterally and are shallow near the gully. When the soil can no longer support the stresses induced by the weight of a tree and the forces acting on it, the tree will fall. The period of excessive loading due to the size and weight of a tree is sometimes mani-

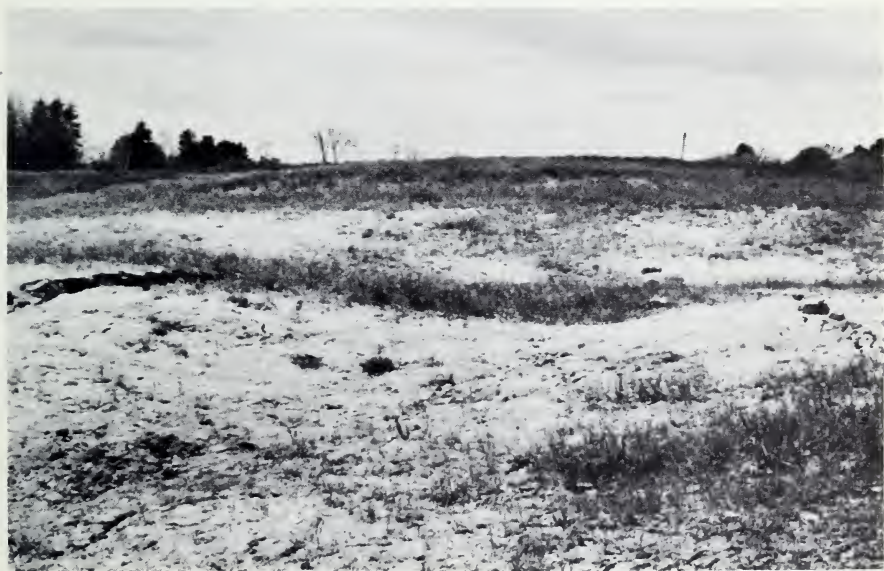
FIGURE 10.—Ground sinking due to seepage on small terrace in Piscataqua River watershed causes "horns" or cracks on surface looking upstream. Durham, N.H.

shed near Durham, N.H. An area of Suffield silt loam on a small terrace bordering a tributary stream was sinking, as shown in figure 10. Water was flowing out of the streambank at the rate of 25 to 30 gallons per minute, and the turbid water was carrying suspended materials downstream. The muddy coloring of a large pond downstream was first noticed in 1960. In the spring of 1961 ground sinking occurred above the terrace slope, cutting into a farm road.

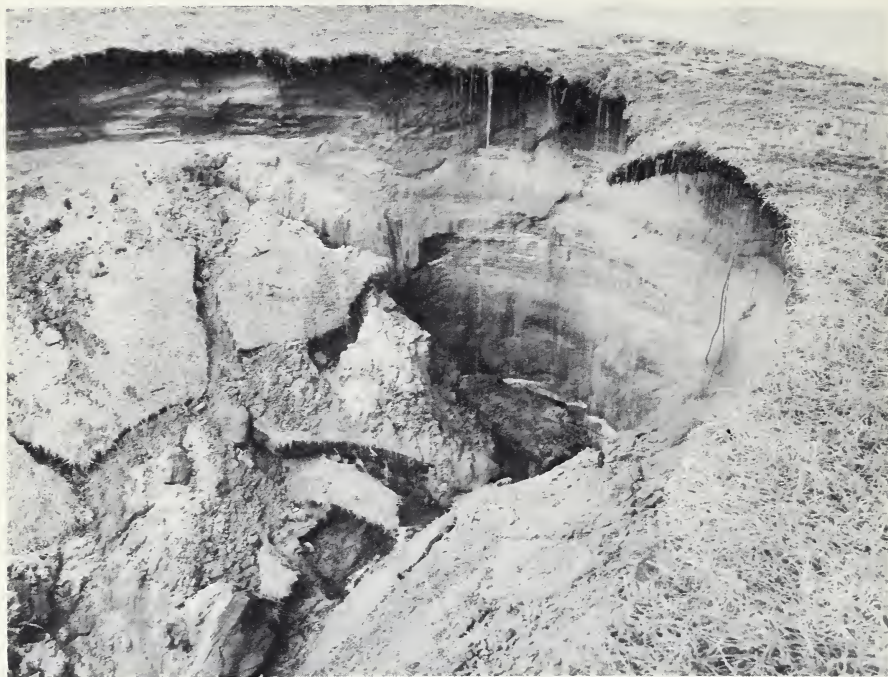
FIGURE 11.—Runoff causing gully erosion. Piermont, N.H.

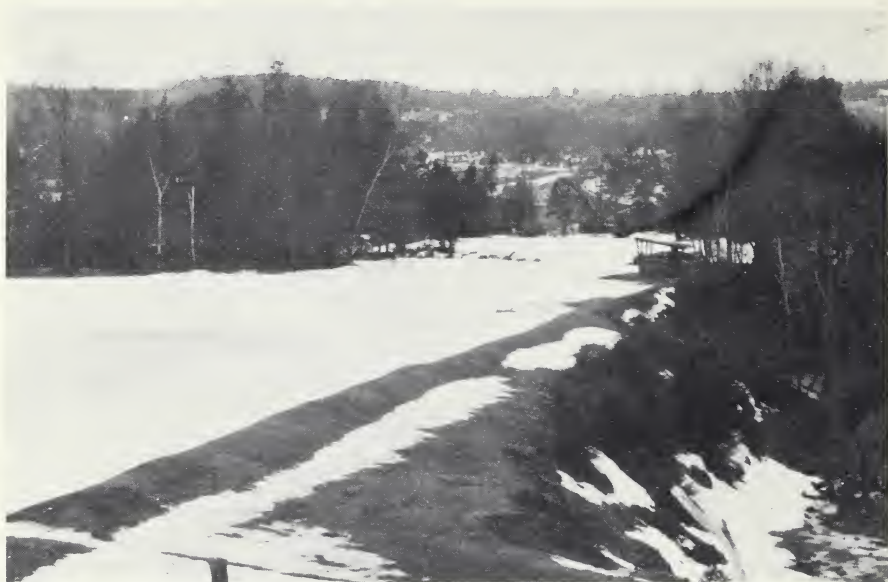
FIGURE 12.—River-terrace dikes protect hayland, shown covered with snow, from gully encroachment. North Charlestown, N.H., 1959.

Two problem sites are described here because of their similarity. The first site is located on the westerly slope of the first terrace bordering the Connecticut River at North Charlestown, N.H. The initial cause of the gully is not known, but it seems to be related to land clearing. The area is well drained. The gully cuts into an 8-acre hayfield, as shown in figure 12.

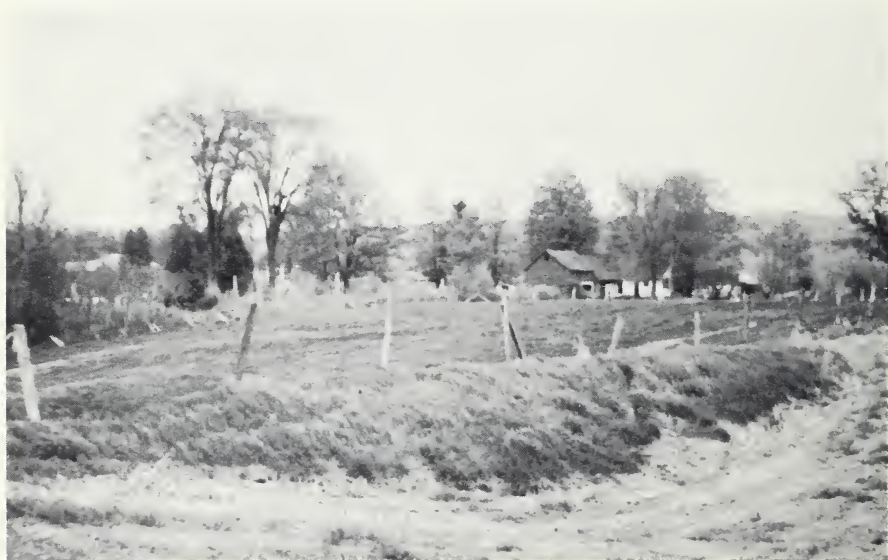
FIGURE 13.—Diked gully at Westminster, Vt., 1959.

The second problem site is located on the first terrace of the Connecticut River at Westminster, Vt. The stabilized gully borders a 36-acre field. The area directly in front of the gully has been scooped out in building a dike to prevent runoff from entering the gully. Water ponded on the field drains vertically within a week, without causing any problem. (Fig. 13.)

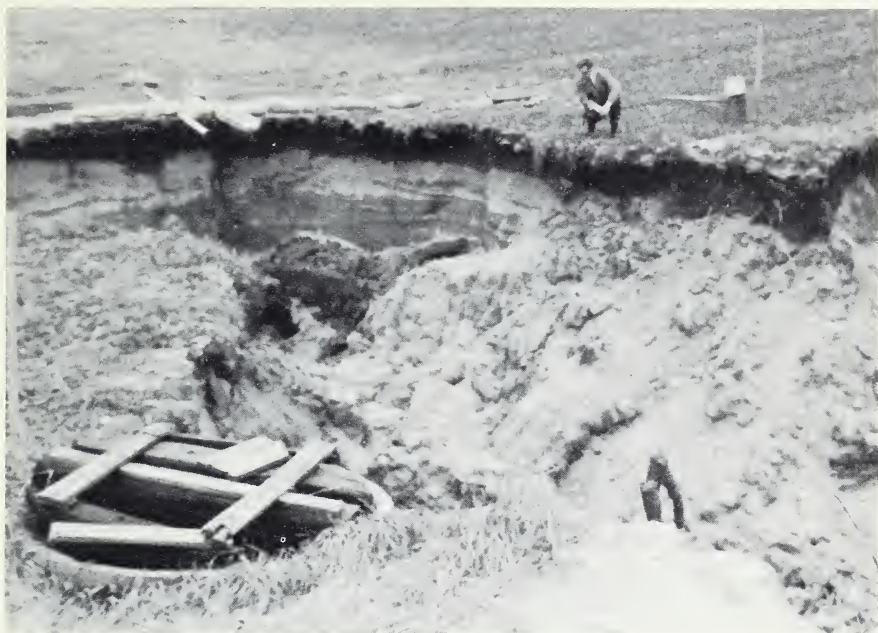
FIGURE 14.—Extensive erosion that removed damaged dike and left dry well high and dry. Piermont, N.H., 1962.

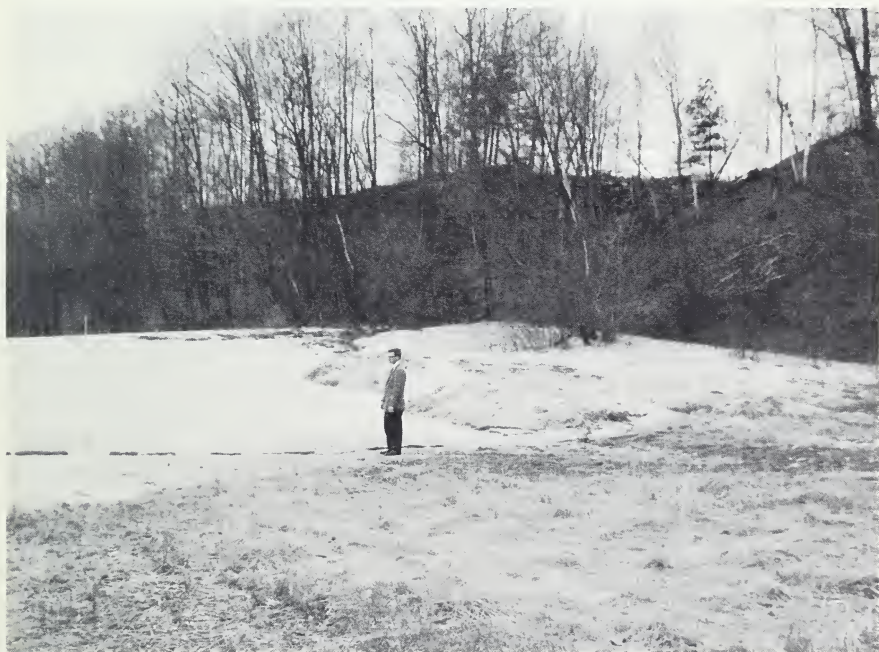
FIGURE 15.—Sandy material covers productive bottom land after passing down scarp. Note first-terrace gully in upper right corner. Piermont, N.H., 1962.

The farmer has been concerned that the sandy sediment discharged from the gully will prevent the full use of productive bottom land, as shown in figure 15. The design of the control has now been modified to equalize the drainage areas assigned to each dry well. The soil can effectively drain ponded water, and the control should be successful as now designed and installed. Seepage has not been observed at this site.

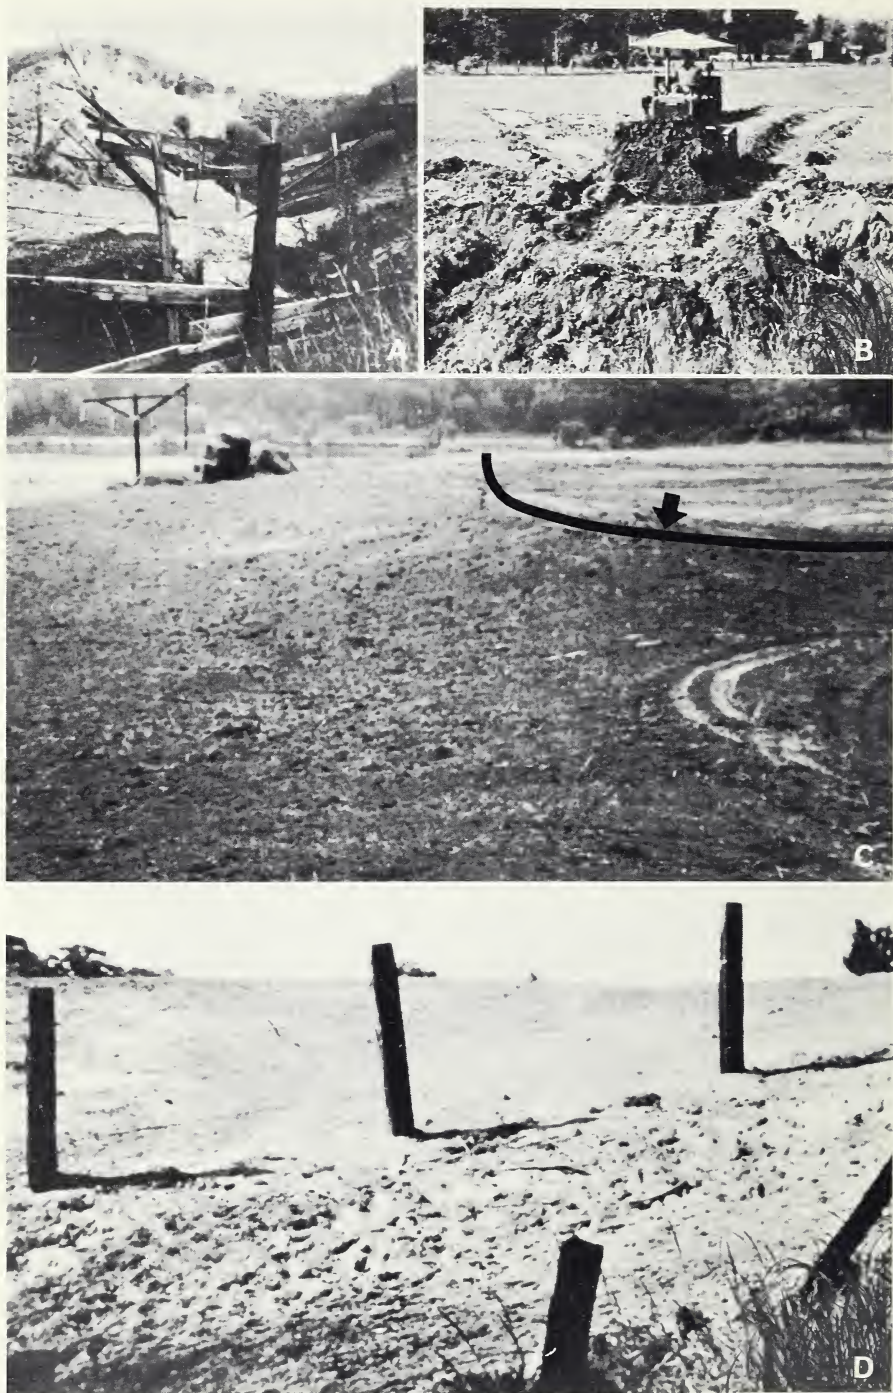
FIGURE 16.—Views of gully before and after control measures were installed. Charlestown, N.H., 1959. *A*, Gully on sandy loam of first terrace; *B*, earth moving to fill gully and form pond; *C*, area seeded; note dike protecting problem area from surface water; *D*, realigned fence (see *A*) along cattle path and control area in background fenced against cattle.
